석면농도측정 결과보고서

석면해체·제거작업 신고번호		익 산 - 20230099
신고현장	현장명(공사명, 작업명)	전화번호
	세경1차아파트 재건축정비사업 석면해체공사	063-838-8300
	소재지	
전라북도 익산시 서동로18길 66 (동산동, 세경아파트) 1		
신고인	석면해체제거작업 명(상호)	고용노동부 등록번호
	에스에이치토건(주)	3286

석면농도측정 결과표

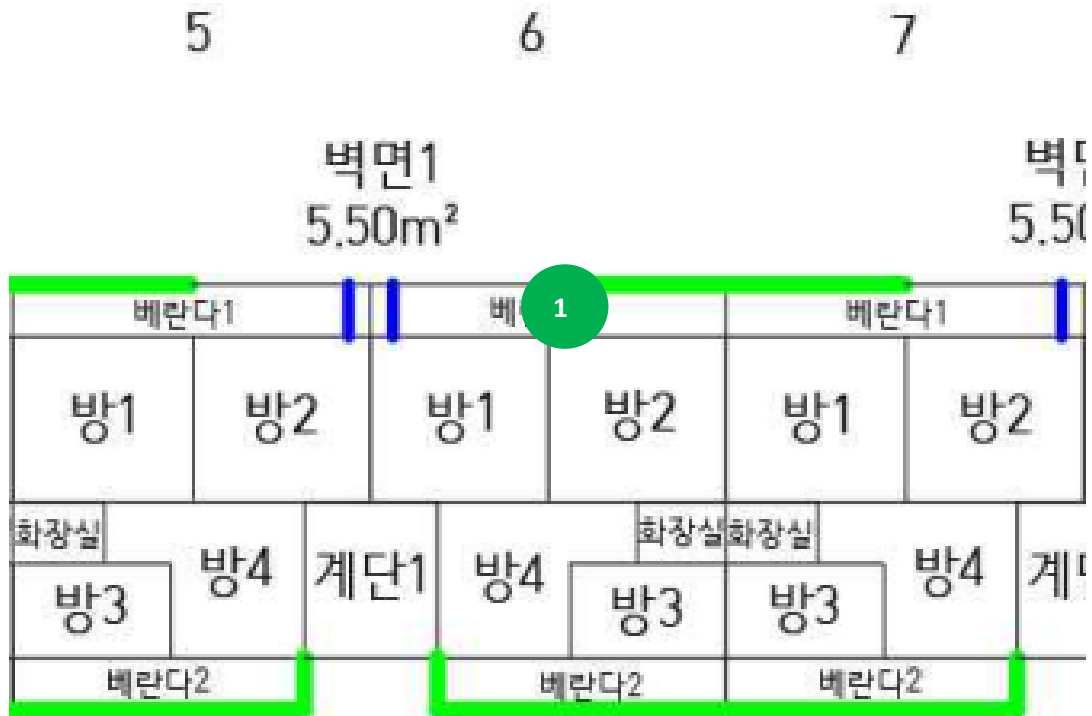
2동 5,6라인(506호)

시료 번호	측정지점	유량 (l/min)	포집시간 (min)	공기채취량(L)	측정농도 (개/cm ³)	초과여부
0	공시료	-	-	-	0	-
0	공시료	-	-	-	0	-
1	2동5,6라인, 506호 -1	10.36	100	1036	0.002	기준미만
2	2동5,6라인, 405호 -1	10.42	100	1042	0.002	기준미만
3	2동5,6라인, 305호 -1	10.43	100	1043	0.003	기준미만
4	2동5,6라인, 205호 -1	10.47	100	1047	0.002	기준미만
5	2동5,6라인, 105호 -1	10.21	100	1021	0.003	기준미만
